TENNESSEE VALLEY AUTHORITY
DIVISION OF WATER CONTROL PLANNING
HYDRAULIC DATA BRANCH

PRECIPITATION
IN
TENNESSEE RIVER BASIN

—
REPORT NO. O-243-328
—

JOHNSON CITY, TENNESSEE, FLOODED BY BRUSH CREEK

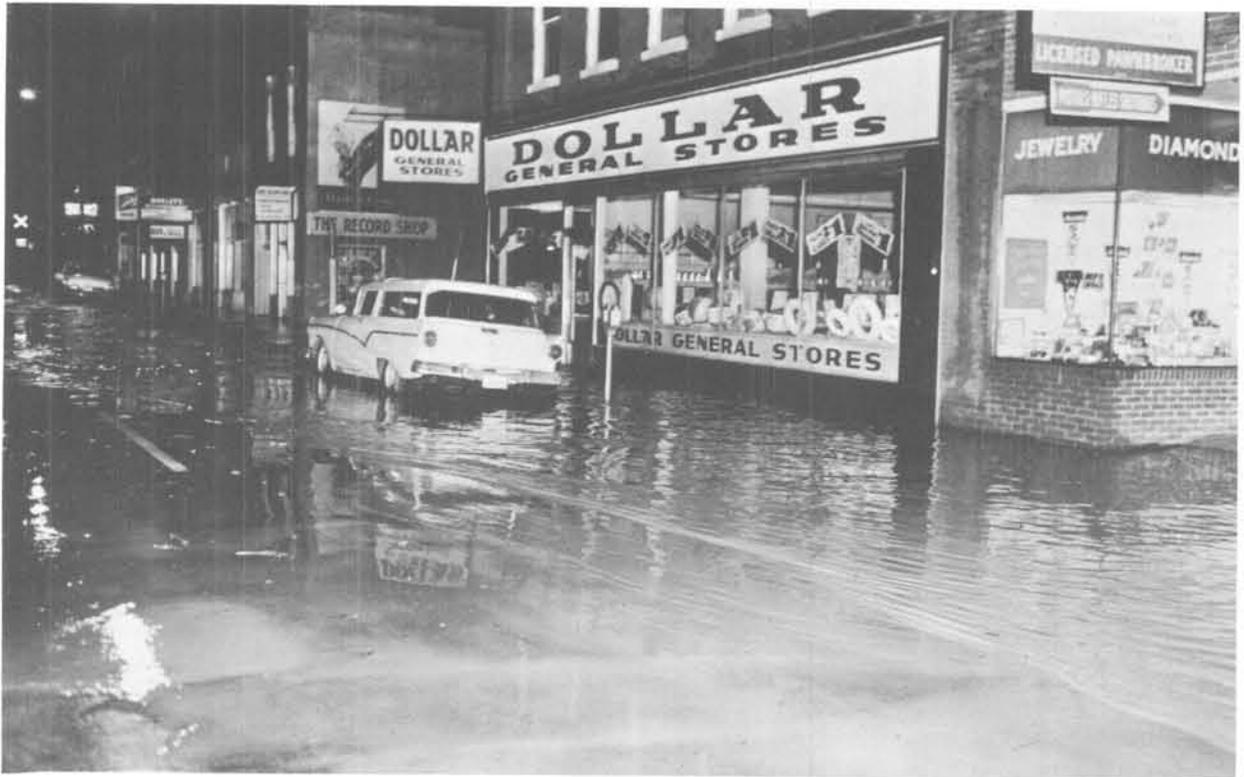
View looking east on West Main Street. Lamont Street is between Dollar Store and The Record Shop.

In the Johnson City business district Main Street was flooded from Fountain Square to the Bus Terminal, a distance of 600 feet. The flood waters here were generally just over the sidewalks and entered three or four buildings to shallow depths, causing little damage. As mentioned earlier, water flowed down Market Street from the west, and the street was flooded from Whitney Street to Fountain Square, a distance of 1,500 feet. From Whitney to Boone Street the depths were not great but the velocity was high; and water was forced into some buildings, such as Smith-Higgins Company, wholesale druggists, where the water got four inches deep, reaching the lower shelves of their stock and causing damages of \$5,700. Between Boone and Fountain Square, depths on Market Street reached as high as 26 inches at Gay's Cafe on the northwest corner of Market and McClure. Other businesses flooded on Market Street were Gene's Grill, Powells Department Store, Market Street Furniture, Chambers-Williams Drug Store, and Farnsworth Furniture Store. On cross streets in the flooded area, such as McClure and Commerce Streets, several businesses were flooded. These included Fletcher Furniture, Sell Produce, Powell's Annex, Shell Service Station, and Giant Super Market, which had four to six inches in the large building between the above two streets. On Roan Street water was 0.4 foot deep around the Inter-Mountain Telephone Company Building, and water entered the basement. Photographs on pages 5 and 6 show flood scenes in the business district.

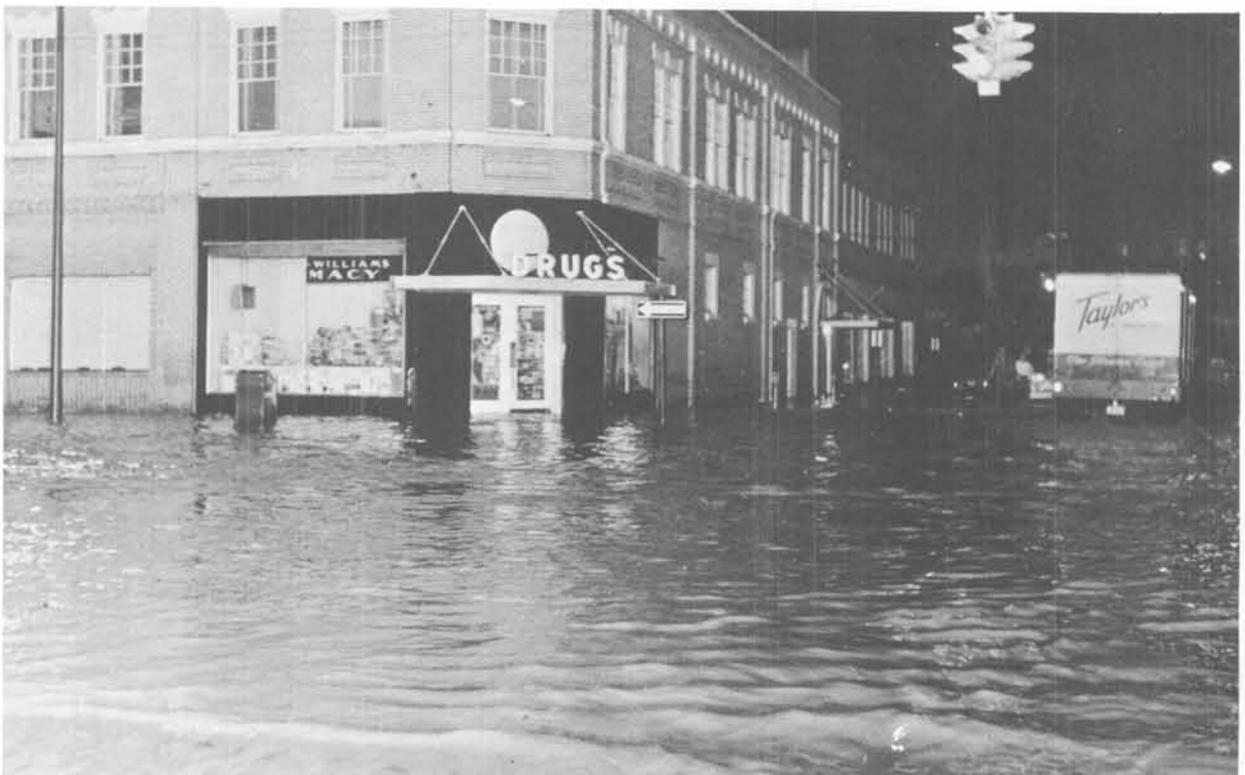
Drugstore located on northwest corner of West Market and Boone Streets. Photograph was taken about 11 p. m., or shortly before the crest stage occurred.

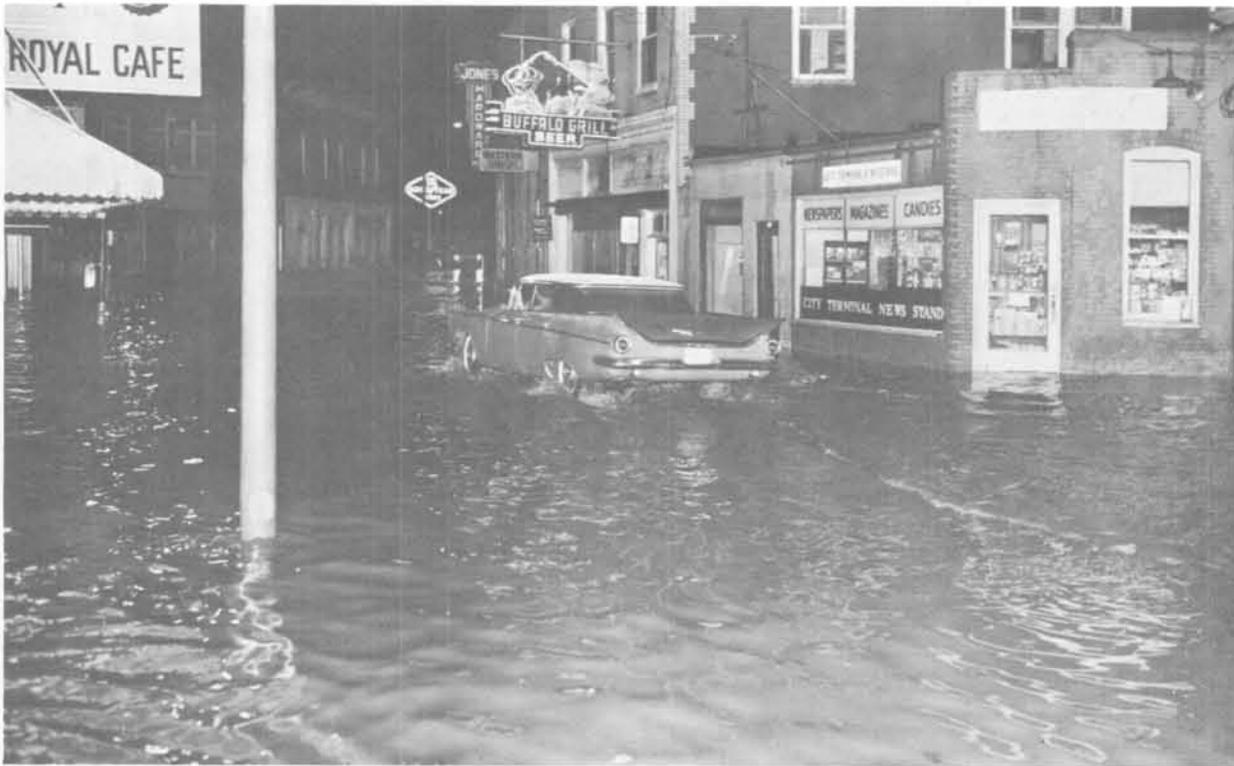
View looking south along Buffalo Street from Fountain Square. Photograph was taken at about 11 p. m. , or shortly before the crest stage occurred.

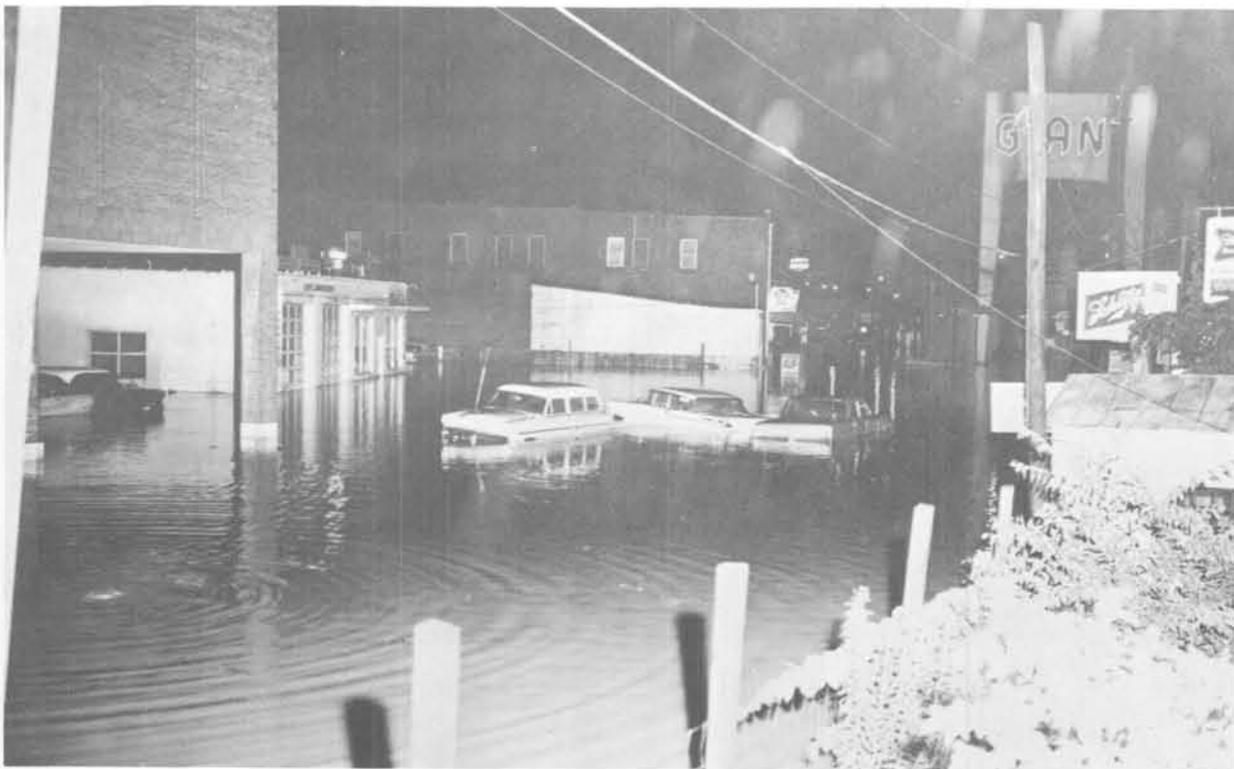
View looking south along Commerce Street from Roan Street. The Brush Creek channel crosses under the street and under the garage in the left center of the picture. Inter-Mountain Telephone Company Building is on the extreme left.

Through the business district of Johnson City flood waters reached varying depths up to 2.6 feet on Commerce Street near the creek crossing. At the corner of Market and McClure water was twenty-six inches deep. The flood waters overtopped the Southern Railway tracks at the depot and downstream for a short distance, crossed Roan Street with depths slightly over one foot, and mostly returned to the channel below the covered section. Flooding downstream from the lower end of the covered channel was not important except for that in a housing development on the north side of East Fairview. At that point a small tributary stream enters Brush Creek. East Fairview crosses the branch on a fairly high fill, and the small drain under the fill was entirely inadequate. With the fill acting as a retention dam, water reached a depth of four feet upstream, flooding several buildings and automobiles parked in the streets of the housing development which was built in the low-lying land along the branch above East Fairview.
